PROJECT DETAILS

Client: Scottish Water

Site: Fort William, Scotland

Application:
Repair and refurbishment of odour control unit

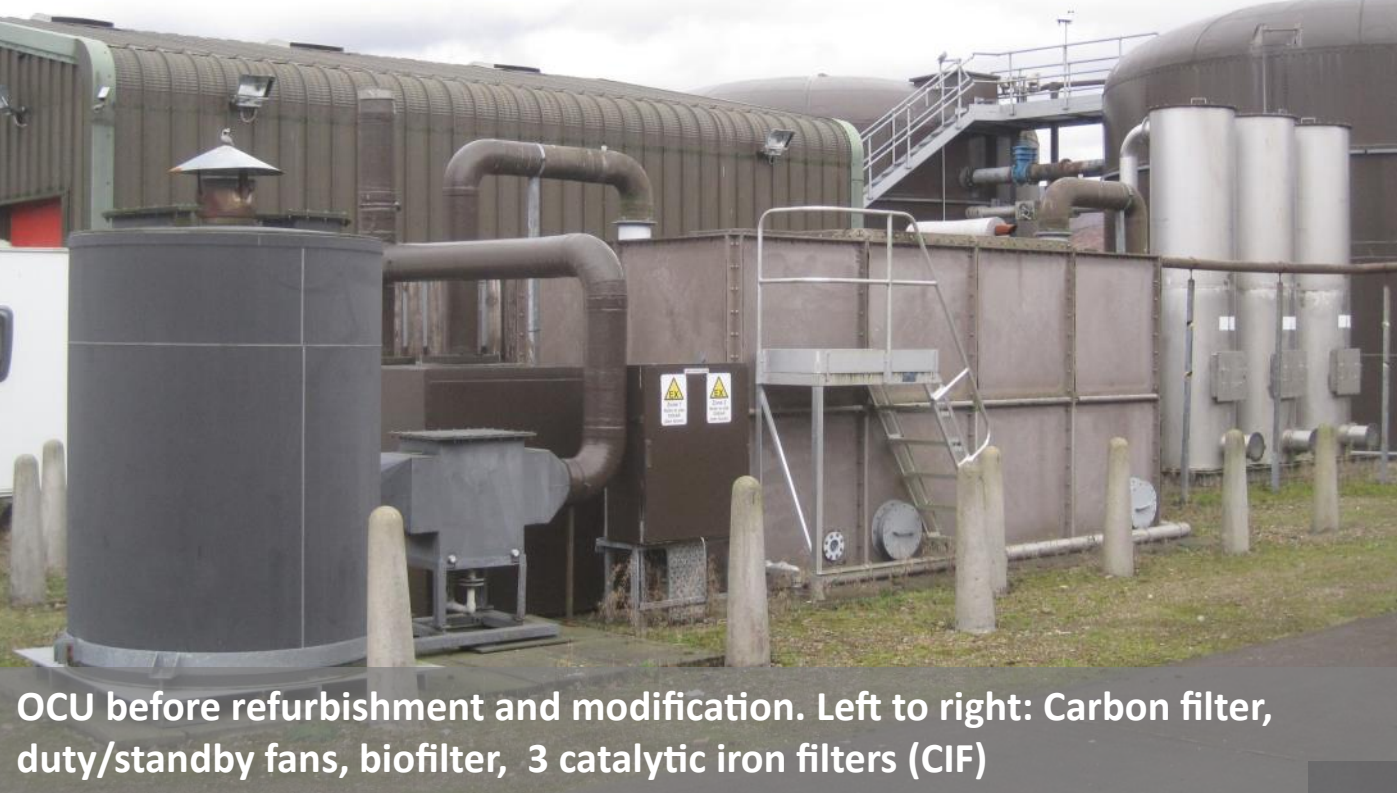
OCU before refurbishment and modification. Left to right: Carbon filter, duty/standby fans, biofilter, 3 catalytic iron filters (CIF)

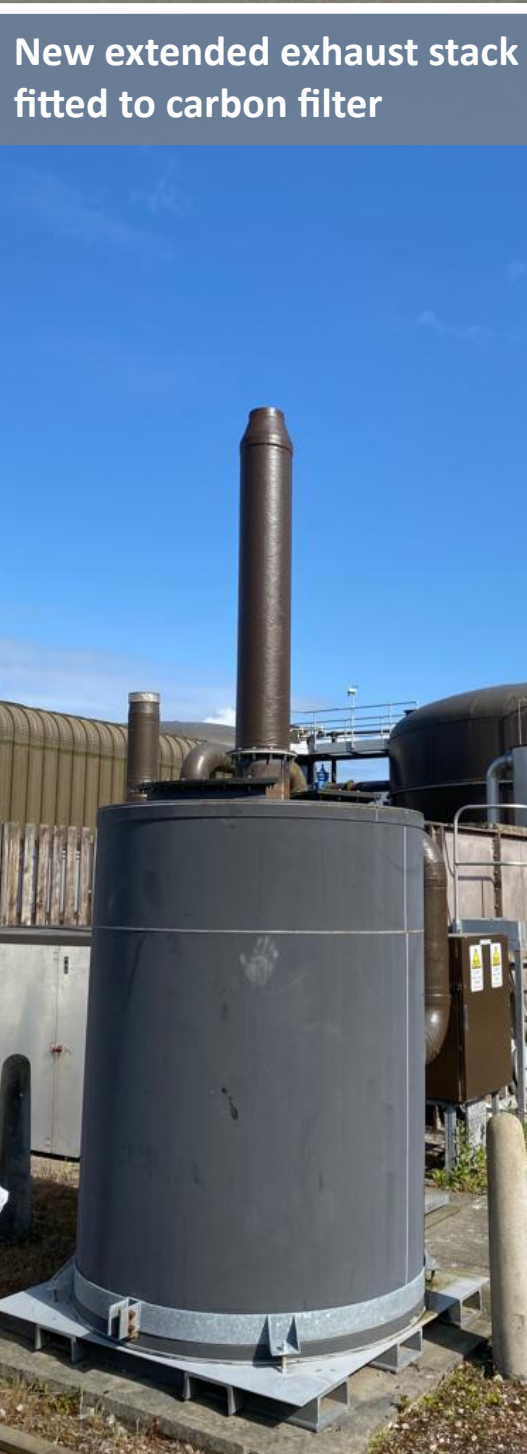
New extended exhaust stack fitted to carbon filter

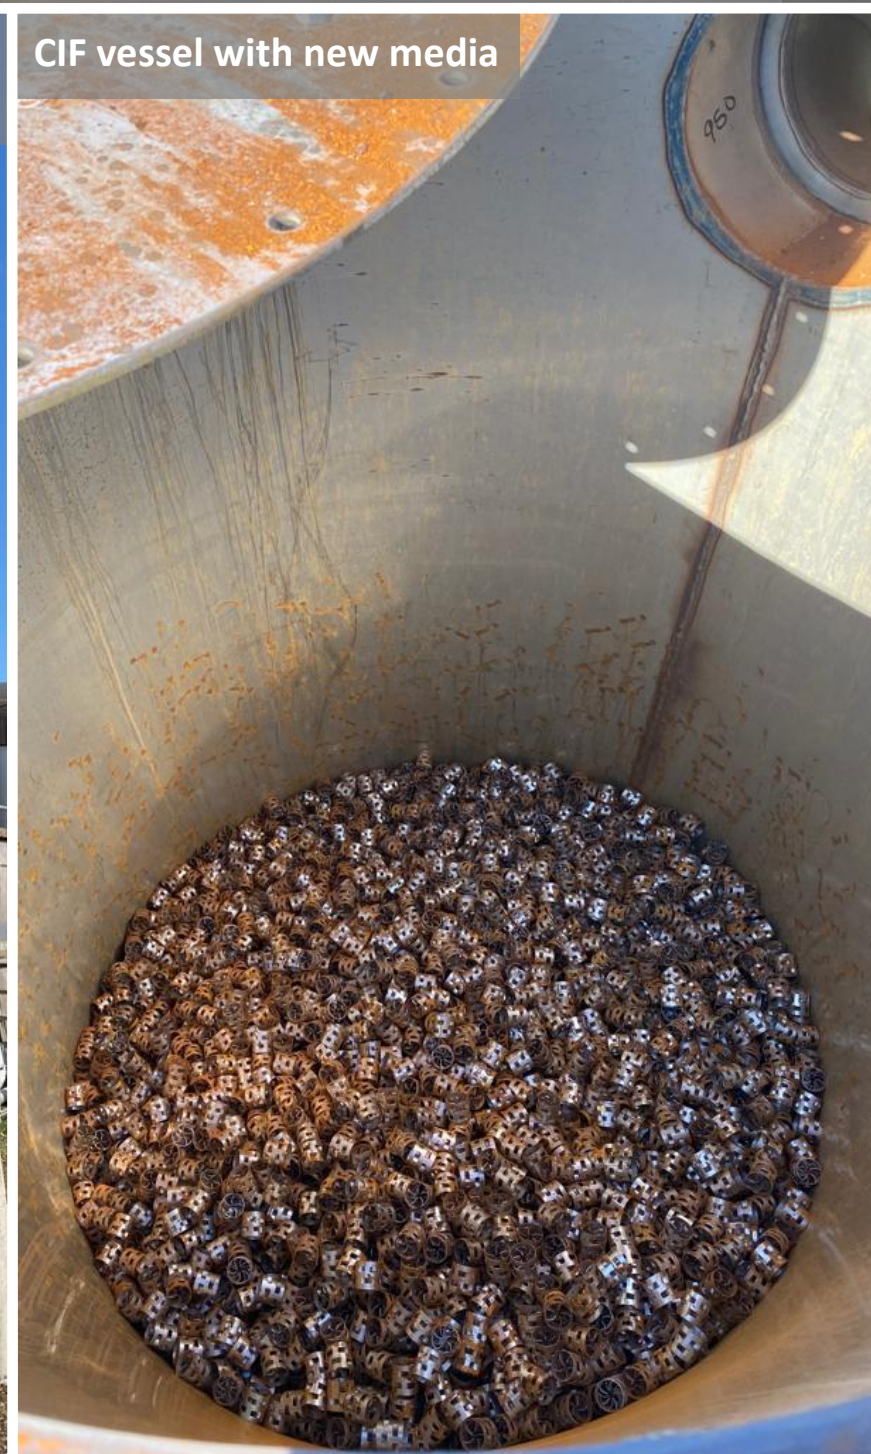
CIF vessel with new media

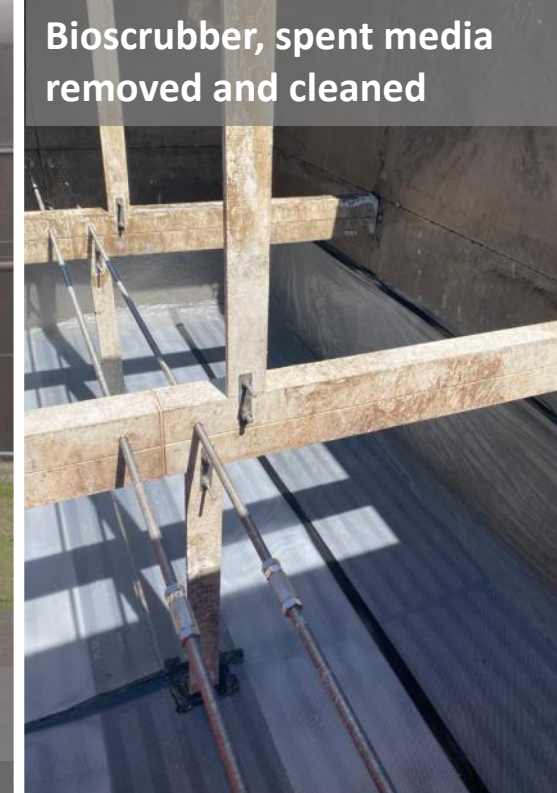
Bioscrubber, spent media removed and cleaned

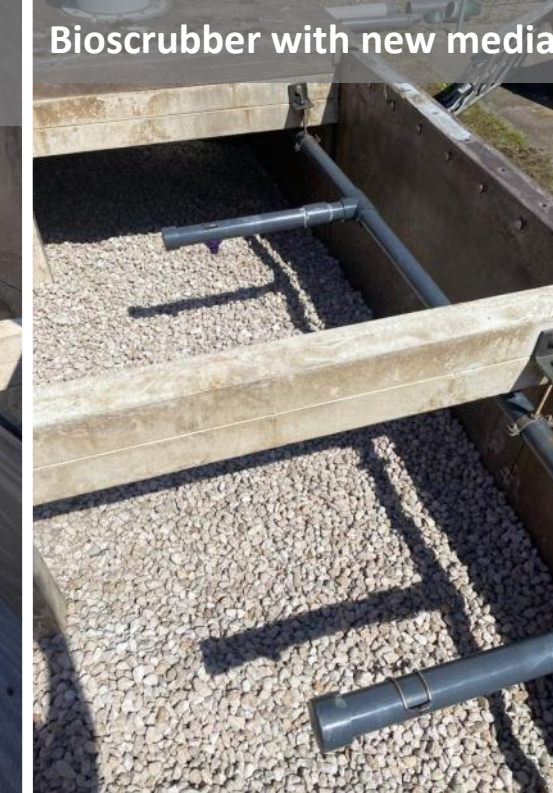
Bioscrubber with new media

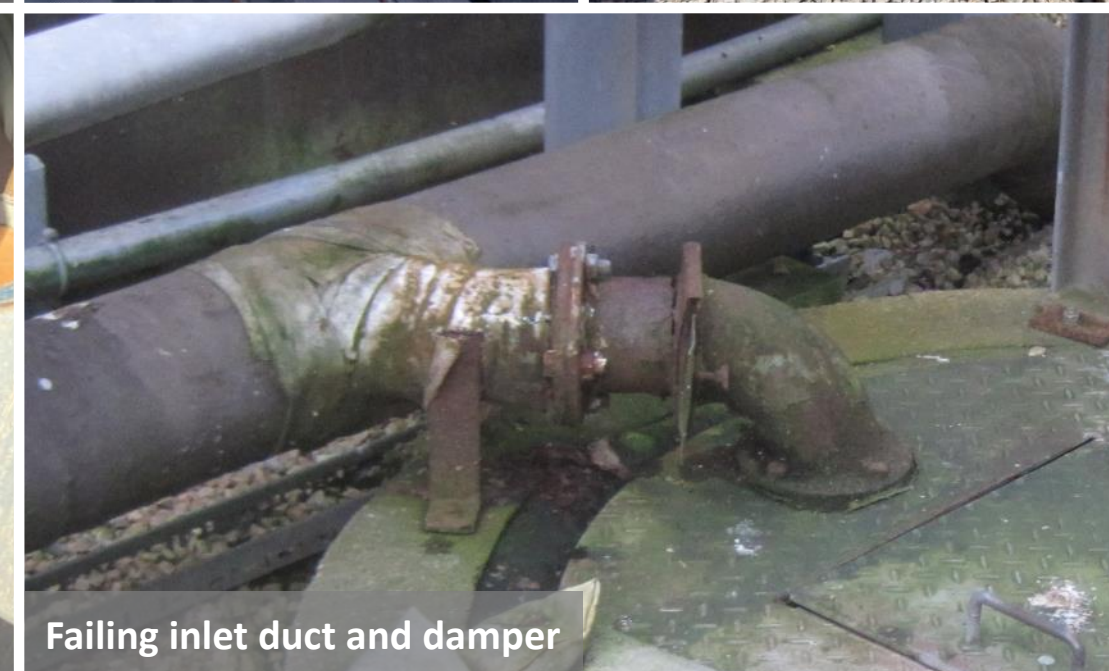
Failing inlet duct and damper

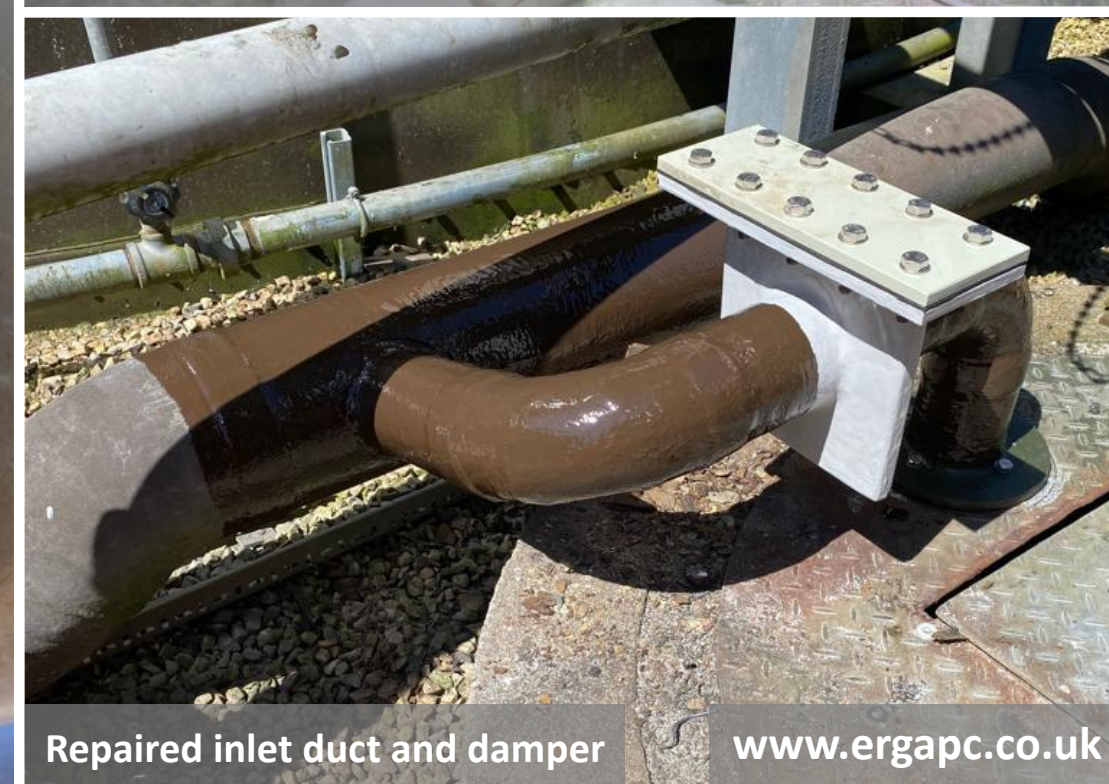
Repaired inlet duct and damper
