Benefits of Long-Term Maintenance for Waste and Energy Minimisation and Process Optimisation

June 2021¹

¹ Paper presented at AquaEnviro on-line conference “Practical Experiences of Odour Management”, June 2021, by Hamish McWillie, Director of ERG APC Maintenance Ltd.

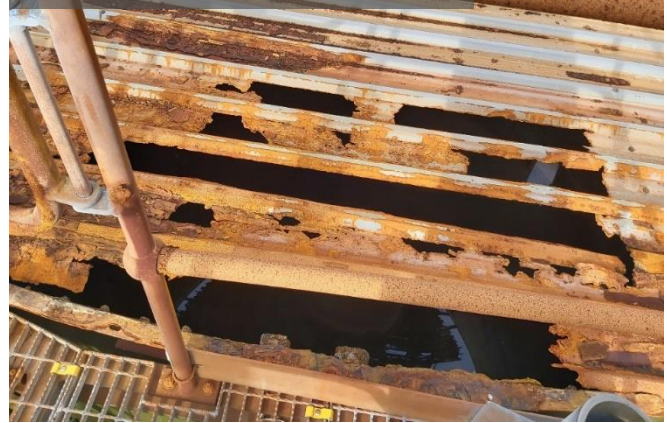
Photo 3

Tank lid and access platform accelerated corrosion caused by extraction duct failure

- Reduced extraction from processes leading to increased H₂S within buildings and around tanks causing corrosion of
 - electrical components (particularly contacts, see photo 2) resulting in serious overheating damage to equipment,
 - steel components (such as tank lids, photo 3) resulting in loss of odorous air containment and unsafe structures,
 - safety elements (for example earth bonding, photo 4) resulting a compromise of the original electrical safety design, and
 - concrete

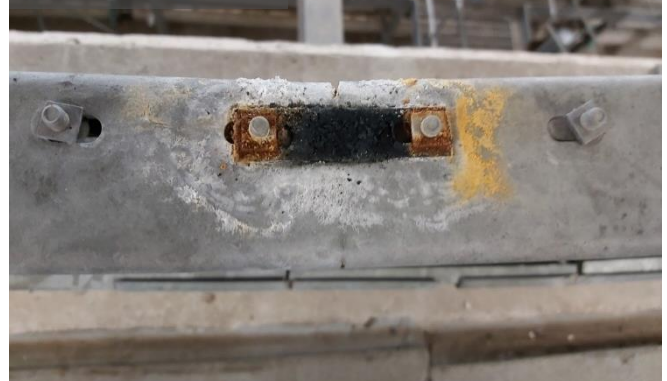
Photo 4

Earth bonding corrosion
