Benefits of Long-Term Maintenance for Waste and Energy Minimisation and Process Optimisation

June 2021¹

¹ Paper presented at AquaEnviro on-line conference “Practical Experiences of Odour Management”, June 2021, by Hamish McWillie, Director of ERG APC Maintenance Ltd.

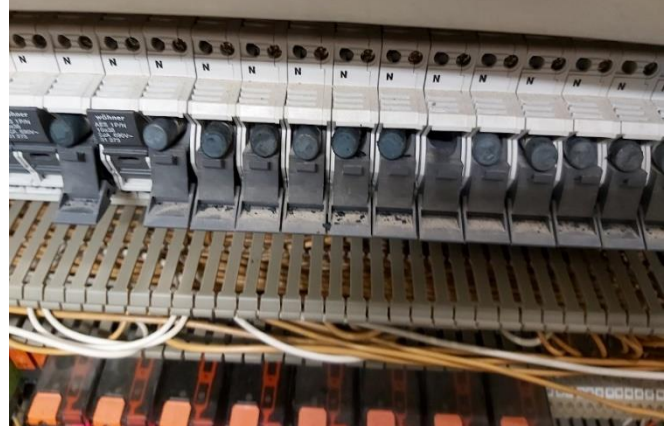
Photo 2

MCC fuses blackened by H₂S exposure giving increased resistance and "hot spots"

- Reduced extraction from processes leading to increased H₂S within buildings and around tanks causing corrosion of
 - electrical components (particularly contacts, see photo 2) resulting in serious overheating damage to equipment,
 - steel components (such as tank lids, photo 3) resulting in loss of odorous air containment and unsafe structures,
 - safety elements (for example earth bonding, photo 4) resulting a compromise of the original electrical safety design, and
 - concreteIn these cases, the building odour levels were not high enough to raise concerns, but the resulting H₂S corrosion has a significant impact.

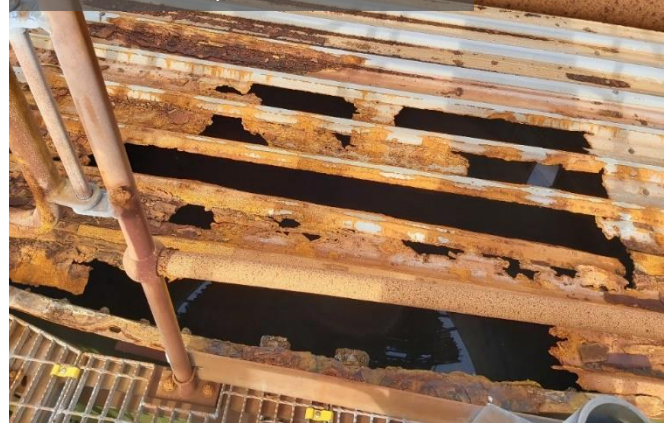
Photo 3

Tank lid and access platform accelerated corrosion caused by extraction duct failure

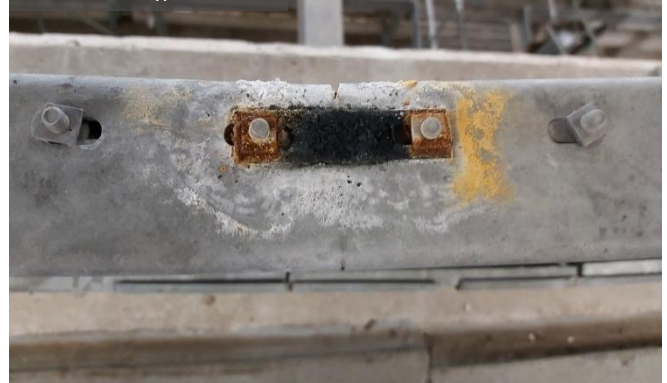
Photo 4

Earth bonding corrosion

For complete OCU systems, well-managed maintenance includes some of the following aspects. ERG's experience is that these potential problem areas are best identified and remedied by a long-term knowledge of each particular site and OCU system. And had these steps been followed, the damage, odour complaints, waste and cost seen in photos 1-4 could have been avoided.
