PROJECT DETAILS

Southern Water, Broomfield Bank STW, Dover

Refurbishment of failing scrubber system

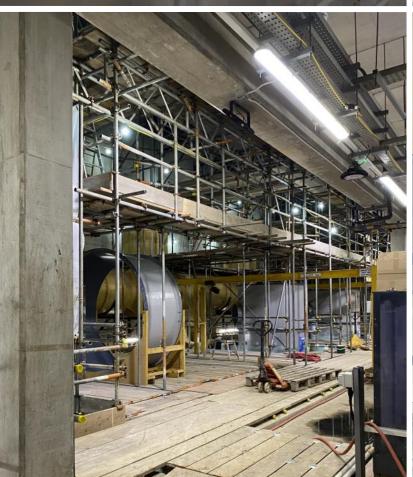
The original OCU was inefficient, several scrubber vessels and a pump had mechanically failed and access to the area was restricted for Southern Water staff and contractors due to chemical leaks.
